Automatic evaluation of sprinkler irrigation systems

Matheus Henrique Souto¹, Edson de Oliveira Vieira^{2*}, Candido Alves da Costa³, Bruna Nogueira Resende⁴,
Miriam Luiza Vieira Lorentz⁵

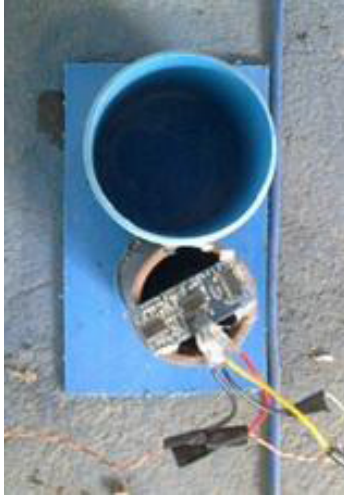
To make readings with selected sensor was required a micro controlled module, opting for Arduino Mega model, which is easy to handle and presented necessary support as well as ports available for such task. The sensor should not obstruct the water inlet of the catch can. To solve this problem, it was coupled to the catch can another piece of PVC tube with 1 cm high unless than the catch can. This piece would communicate with the law of connected vessels, besides this would be closed so that the water did not enter through it (Figure 2).

Figure 2 – Catch can with sensor.

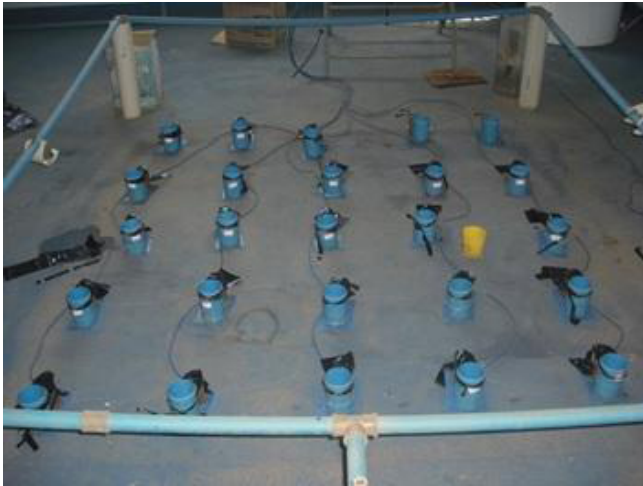
After finalizing the device to obtain the water irrigation depth data, the laboratory tests were started. In this phase of the work an irrigation device was set up in which 25 catch cans with sensors were spaced 40 cm apart to collect the water applied by smalls sprinkler, allowing the calculation of the water uniformity application (Figure 3).

Figure 3 – Test device in the laboratory with the catch cans

In this first test the sensor was programmed in a common way to the standard code found on the internet. However, the results were not as expected, so a specific recalibration was done for each catch can. Recalibration consisted of adding previously known water depths to all catch cans. With this, the sensor was calibrated for each blade added to the catch can. The irrigation depths corresponded to the volumes of 0, 50, 100, 150, 200, 250 and 300 mL, being made level readings of the sensor for each one. Each reading was repeated three times and averaged. Thus, a regression can be obtained and each sensor has a specific equation.

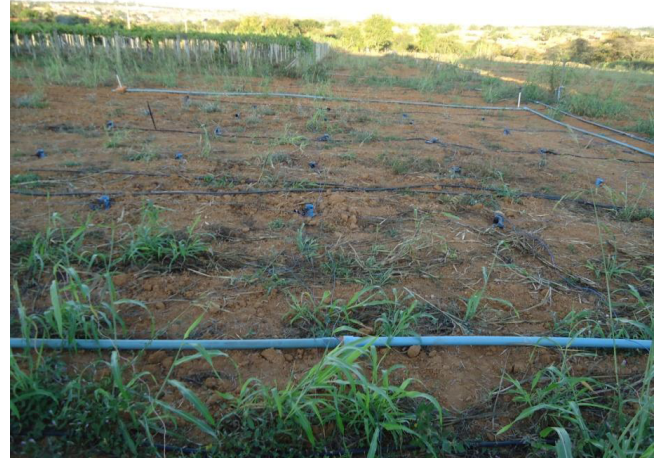
After this stage in the laboratory the experiment was started in an experimental area in which a conventional sprinkler irrigation system with 12 x 12 spacing was set up and again the 25 catch cans with sensors spaced 2 x 2 m were scattered, forming a mesh of catch cans (Figure 4).

Figure 4 – Arrangement of catch cans for experimental area testing

Several irrigation depths were tested with irrigation time of 1; 1,2; 1,5; 2 and 2,5 hours of operation. Another fact to be observed is that these readings were made over 120 days, which is similar to a cycle of a culture equivalent to corn for example. In this way, as catch
